# Yeronga West – Orient Road Park Issues Paper

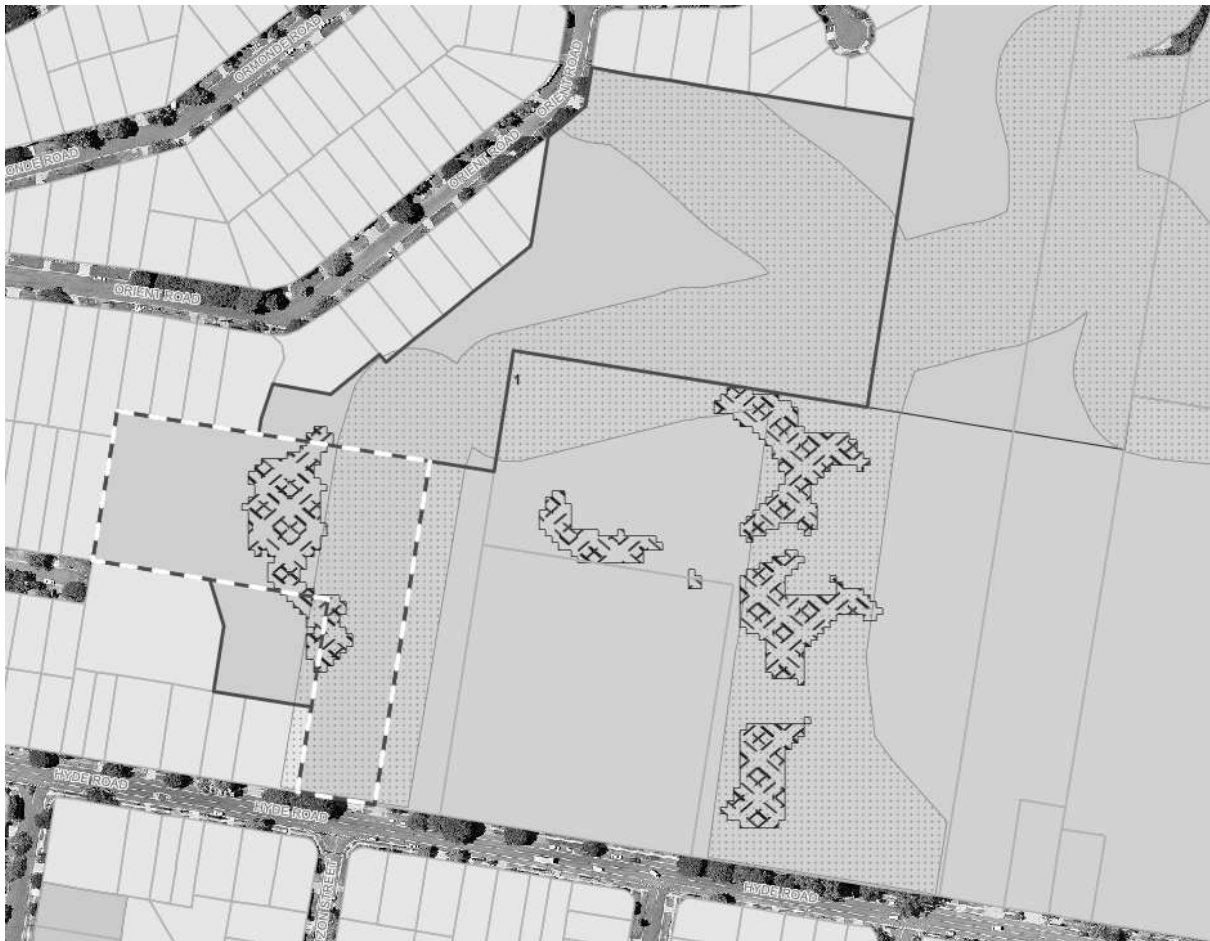
Figure 2 - Zoning, water corridor and wetland

The park appears to provide only for local residents' access as the ends of the path do not connect to any significant corridors for pedestrians nor cyclists, and Council has it zoned "SR1 Sport & Recreation (Local)" – Figure 2, which also shows local waterway corridor and patches of wetlands overlay; although the patches shown on BCC planning are high and dry, and includes a lot of the dry plantings completed in 2009.

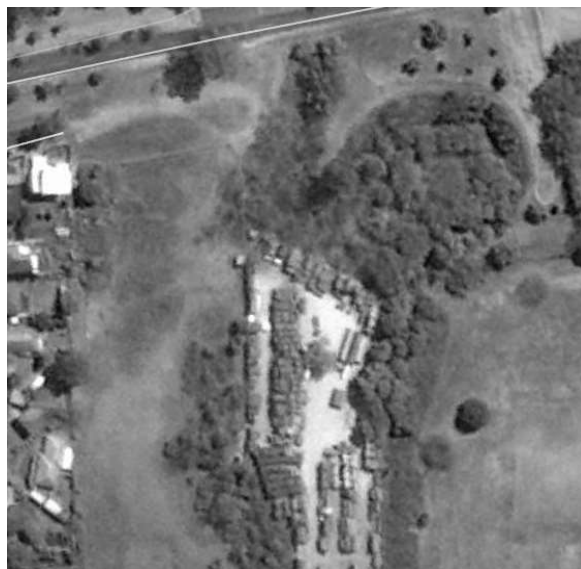
The western catchment creek passing through the Orient Road Park was filled where it passes through 133 Hyde Rd downstream of the horse paddocks, and the creek was piped – sometime between April 2002 and September 2003. Figures 3 & 4 are aerial photos showing the conditions before and after the illegal filling and drainage.

The pipes used in the construction are 2 x 1200mm diameter using re-used steel pile casings, and therefore have limited longevity in the conditions. Just downstream of the filling, the culverts under Brisbane Corso are 2 x 1800mm dia, and thus the construction now constricts the flow by more than 65%. Additionally, the filling of the creek/floodplain has reduced the flood storage by an estimated 1.7 megalitres.

Brisbane City Council (BCC) has no record of any application nor records of design nor construction for these works, and they investigated the issue in 2006. BCC opted to not act (for reasons not provided) against the landowner at the time, and BCC is now time-barred to take further action on the issue. It is noted that even though BCC investigated and were aware of the pipes, they have not been included on council's drainage database or mapping overlays.

Consequently flooding upstream will now be greater in depth, frequency and duration (ie smaller, more frequent events that may have passed without flooding properties will now cause flooding, and more severe events will cause deeper and more prolonged flooding).

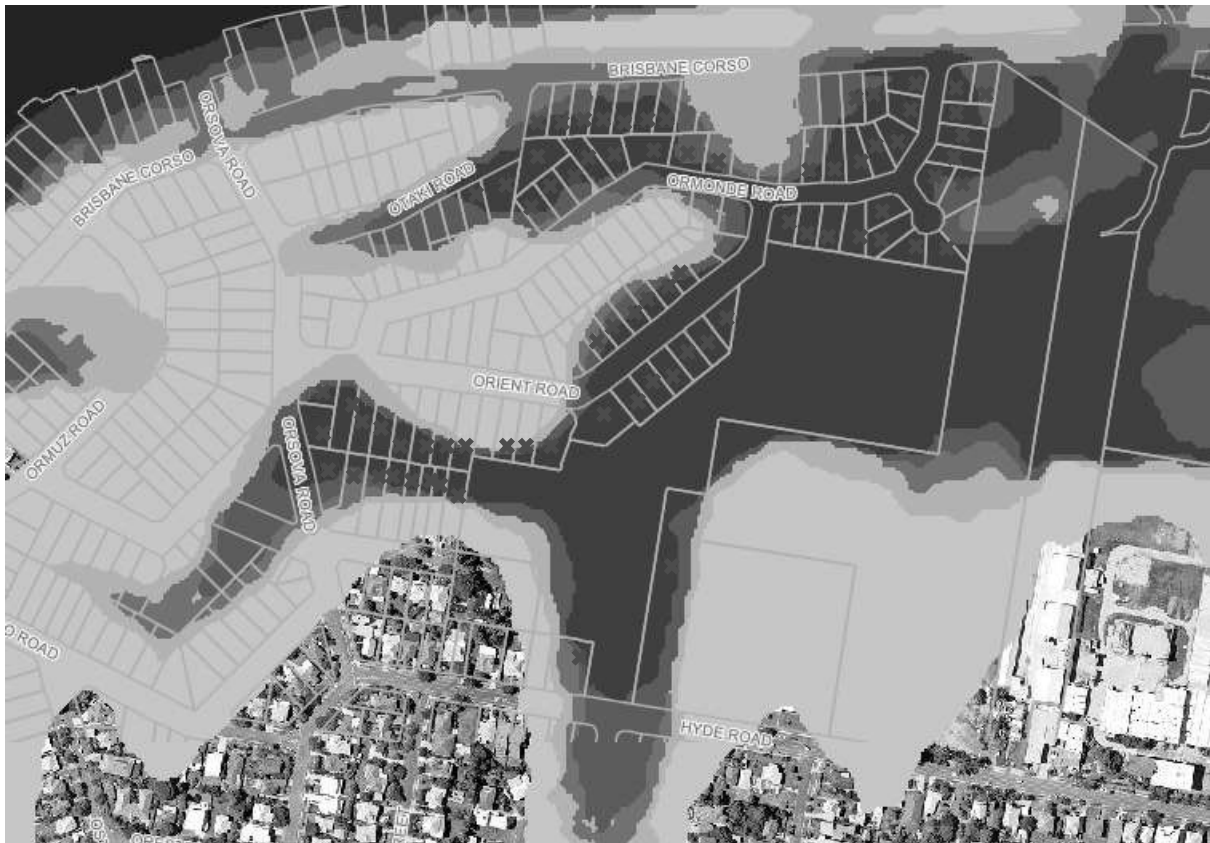
Figure 5 - Affected properties due to illegal filling & drainage (BCC flood mapping)

Properties affected are those in the inundation area of the western creek catchment up to a level when the river/creek breaks its banks over Brisbane Corso, and riverine flooding ensues or the excess floodwater overtops the Corso. The minimum number of properties affected (78) are shown in Figure 5. Flood modelling may show this number is understated.

Affected property owners (Fig 5) could be contacted to advise the increased risk of flooding, and potential actions by them could include:

- A group petition to BCC to seek remedy because of council's inaction when it knew of the problem
- Group action against the property owner of 133 Hyde Rd for its neglect to ensure that improvements were approved prior to purchase
- A class action from the affected owners against both council and the property owner of 133 Hyde Rd for compensation should flooding occur and damage affected properties. Compensation can include increased insurance premiums that may result in the increased risk of flooding

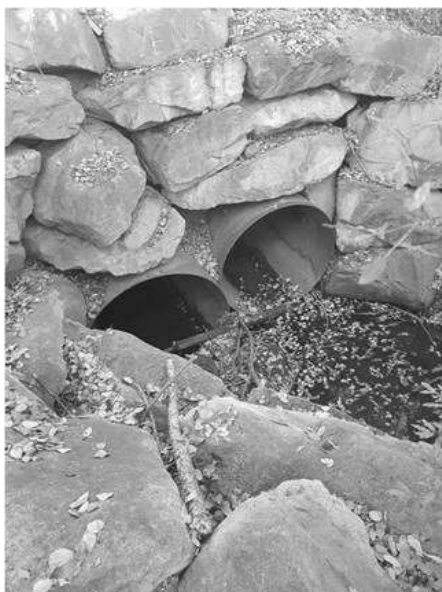
The inlet to the installed pipes is above the invert of the creek (Figure 6), and exacerbates both ponding in the creek upstream and increased flood levels caused by the small pipe sizes. This has caused ponding and subsequent weed growth, and stagnating water with consequent safety concerns. Excavation/deepening of the creek upstream of the pipes was carried out around June 2005.

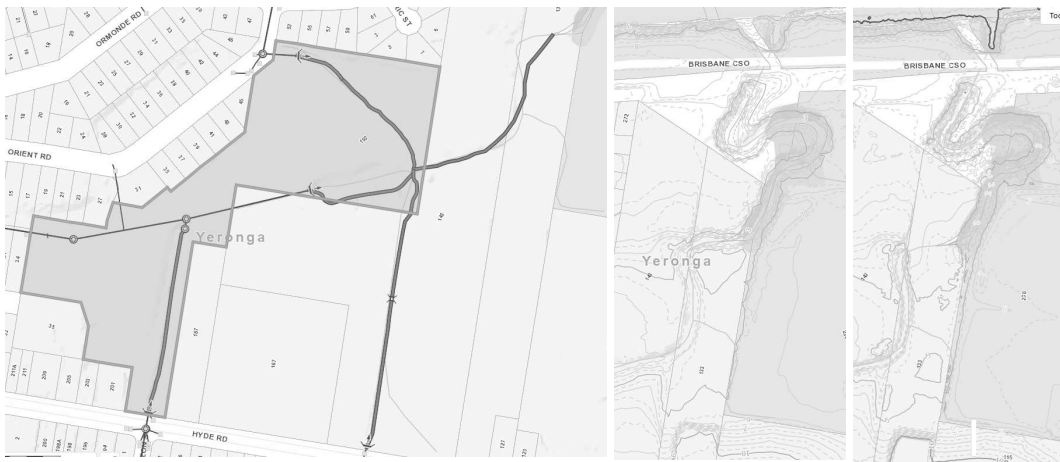
*Drainage entering and inside Orient Road Park (note pipes in 133 Hyde not shown)*

*2002 contours 133 Hyde*

*2019 contours 133 Hyde*
